# ANNUAL INSPECTION BY A QUALIFIED PROFESSIONAL ENGINEER

ALL CCR IMPOUNDMENTS  
*CCR Rule Section 257.83(b)*

## ASBURY POWER PLANT

January 17, 2021

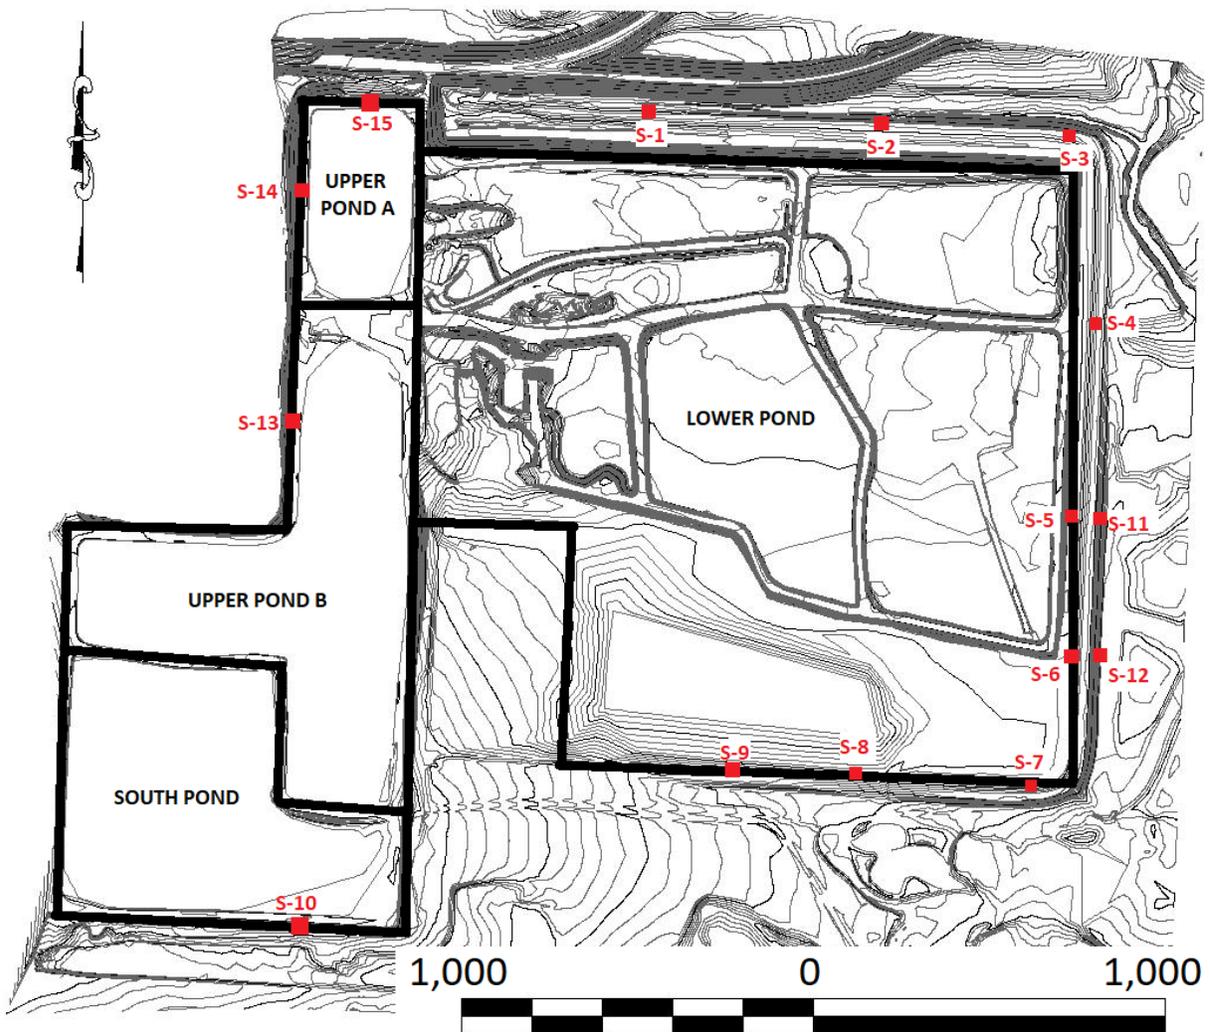
The general location of the vertical deflection monuments is shown on the Site Plan below. The vertical deflection monuments are identified as S-1 through S-15. Vertical deflection monuments S-1 through S-12 are located in close proximity to the twelve (12) settlement monuments, SM-1 through SM-12.
