ANNUAL INSPECTION BY A QUALIFIED PROFESSIONAL ENGINEER

ALL CCR IMPOUNDMENTS
CCR Rule Section 257.83(b)

ASBURY POWER PLANT

RE: **Annual Inspection by a Qualified Professional Engineer –**
CCR Rule Section 257.83(b)
The Empire District Electric Company – Asbury Power Plant
Asbury, Missouri
PPI Project Number: 231518-2022

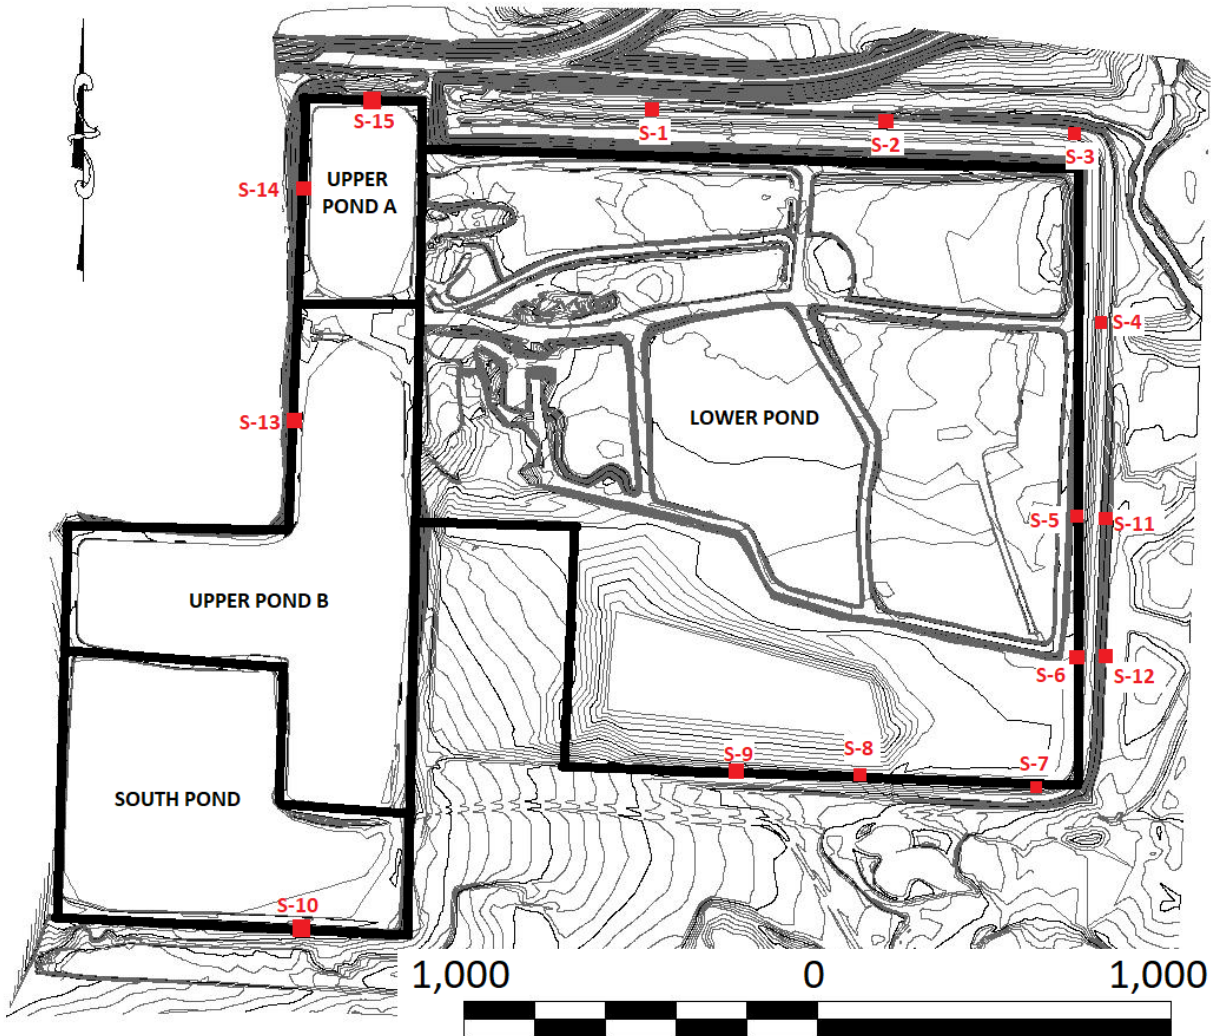
The general location of the vertical deflection monuments is shown on the Site Plan below. The vertical deflection monuments are identified as S-1 through S-15. Vertical deflection monuments S-1 through S-12 are located in close proximity to the twelve (12) settlement monuments, SM-1 through SM-12.

Empire's Generation Performance Manager confirmed that the vertical deflection monuments have been monitored monthly over the past year, and readings have been stable over time.
