ANNUAL INSPECTION BY A QUALIFIED PROFESSIONAL ENGINEER

ALL CCR IMPOUNDMENTS
CCR Rule Section 257.83(b)

ASBURY POWER PLANT

January 17, 2023

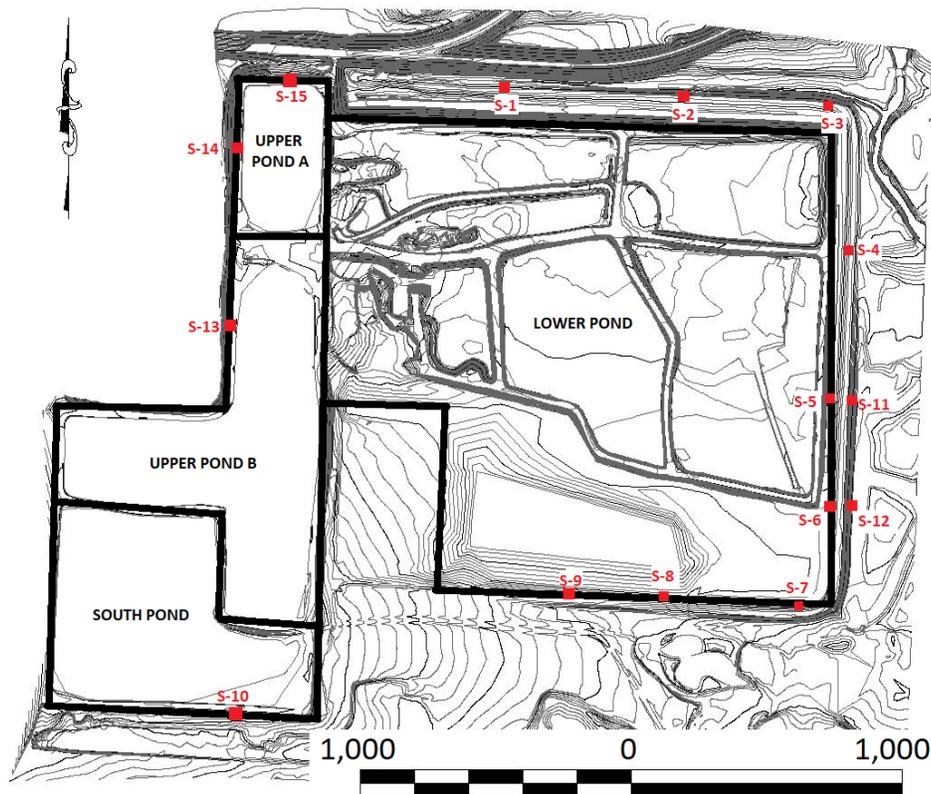
The Site Plan below shows the historic location of the vertical deflection monuments, identified as S-1 through S-15. Settlement monuments SM-1 through SM-12 were located in close proximity to the corresponding vertical deflection monument.

Empire’s Generation Performance Manager confirmed that the vertical deflection monuments had been monitored monthly since the date of PPI’s 2022 Annual Inspection and that the readings have been stable over time. Several of the vertical deflection monuments were removed during completion of the Closure Project as a function of the Site Grading Plan, and others were disturbed. Empire continued to monitor the remaining vertical deflection monuments on a monthly basis through January 10, 2023. On January 17, 2023, the Project Team determined that it was appropriate to remove the remaining vertical deflection monuments; that work was completed by the Contractor on the same day.

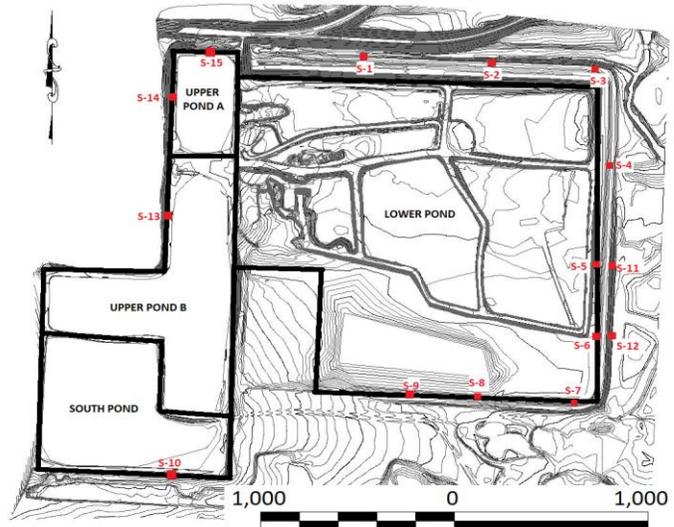
The exhibit below is presented for general scale only; the Impoundment Closure was nearing completion at the time of the inspection. The geometry has changed, as noted on this form.

Summarize Overall Condition of Levee Embankments: The overall condition of the perimeter levee embankments is good. The Closure Project affected the geometry of the perimeter earthen embankments along portions of Upper Pond A, Upper Pond B, the South Pond, and the South and Southeast sides of the Lower Pond. The overall embankment heights were reduced. Existing vegetation was disturbed and/or completely removed around most of the perimeter earthen embankments as part of the Closure Project.

Summarize Areas of Concern / Recommended Action Items: As of the date of the inspection, the Contractor still had quite a bit of work to do with final clean up and re-establishing vegetation. It is anticipated that most of the areas of concern identified during the levee inspection will be addressed prior to the Final Punch List Walk scheduled for January 17, 2023. Remediation of shallow erosion channels that have developed in areas of the North Slope of Upper Pond A is planned, as well as installation of Curlex Erosion Control Mat. Other finish grading should address minor concerns in the levee embankment crest, such as shallow ruts and excess soil piled at the crest of the slope, resulting from construction. Given the time of year, new vegetation will likely not be established until spring.
