ANNUAL INSPECTION BY A QUALIFIED PROFESSIONAL ENGINEER

ALL CCR IMPOUNDMENTS
CCR Rule Section 257.83(b)

ASBURY POWER PLANT

December 13, 2025

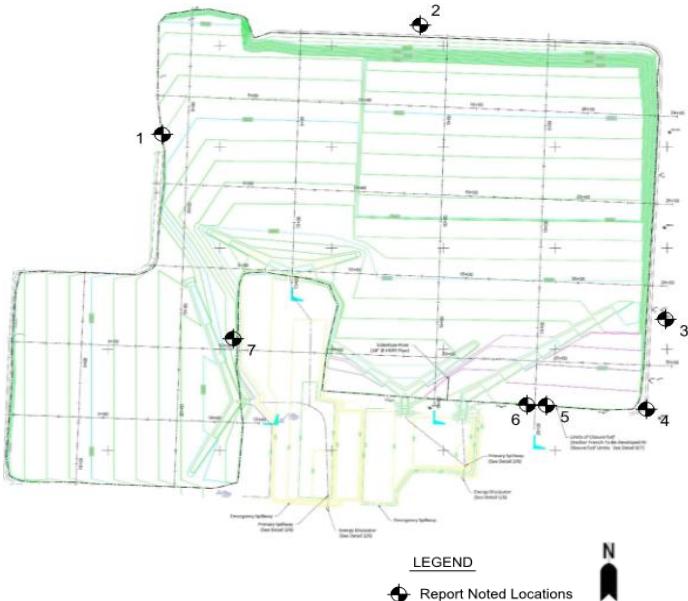
Summarize Overall Condition of Levee Embankments: The overall condition of the perimeter levee embankments is good. Vegetation has been mostly restored following the Closure Project.
Drainage flowing over anchor trench on south side (east end) needs addressed.

The following items were observed during the annual inspection, and correspond to the numbers in the figure above.

No. 1 - NW Erosion Feature. A small (~3'x1.5'x0.5') Erosional feature resulting from moving water towards the impoundment from the perimeter road. Drainage appears to be causing fine migration into the perimeter anchor trench filled with large stone.

No. 2 - Erosion & Slope Failure Along Creek on North Side. ~75' long slope failure that is ~25' from the turf edge at the closest point. **Recommendation:** Perform embankment repair to stabilize slope.

No. 3 - Gully erosion on slope near MW5AR. Three (3) 0.5-1 ft. deep gullies are present.

No. 4 - Seepage at SE corner. Surface appear disturbed within general area.

Seepage noted east of the access road slope NW of MW5. **Recommendation:** Repair area by surface grading and placement of a low permeability material such as clay and bentonite. Establish vegetation and monitor.

No. 5 - SE Gully Erosion. ~0.5 to 1' Deep Gully Erosions at this location with multiple small ones in ~150 ft. length of the berm. **Recommendation:** Fill gullies with compacted fill in the short term, but the entire area appears to drain over the berm in this general area. Regrading of this area may be required, and/or the placement of additional properly constructed permitted outfall(s).

No. 6 - Depression in anchor trench. ~3'X2'X1.5' depression within the rip-rap edge - Down Slope was saturated with slight seepage. A bulge in the berm may indicate piping and deposition of soil fines is occurring. **Recommendation:** Most likely associated with drainage, similar to No. 5. Excavation of the piping area and proper fill placement within the affected area, followed by stone replacement within the anchor trench.

No. 7 - Small area of erosion. ~0.5' to 0.8' Deep Gully Erosions at this location with multiple smaller ones in ~75 ft. north towards detention basin. **Recommendation:** Regrade and replace with larger stone.

Recommendation: Fill eroded area & monitor to see if regrading the road in this area is needed.

Recommendation: Re-grade to fill gullies & establish vegetation asap. Monitor to determine if additional erosion protection or re-grading is necessary.
