ANNUAL INSPECTION BY A QUALIFIED PROFESSIONAL ENGINEER

ALL CCR IMPOUNDMENTS
CCR Rule Section 257.83(b)

ASBURY POWER PLANT

January 17, 2020

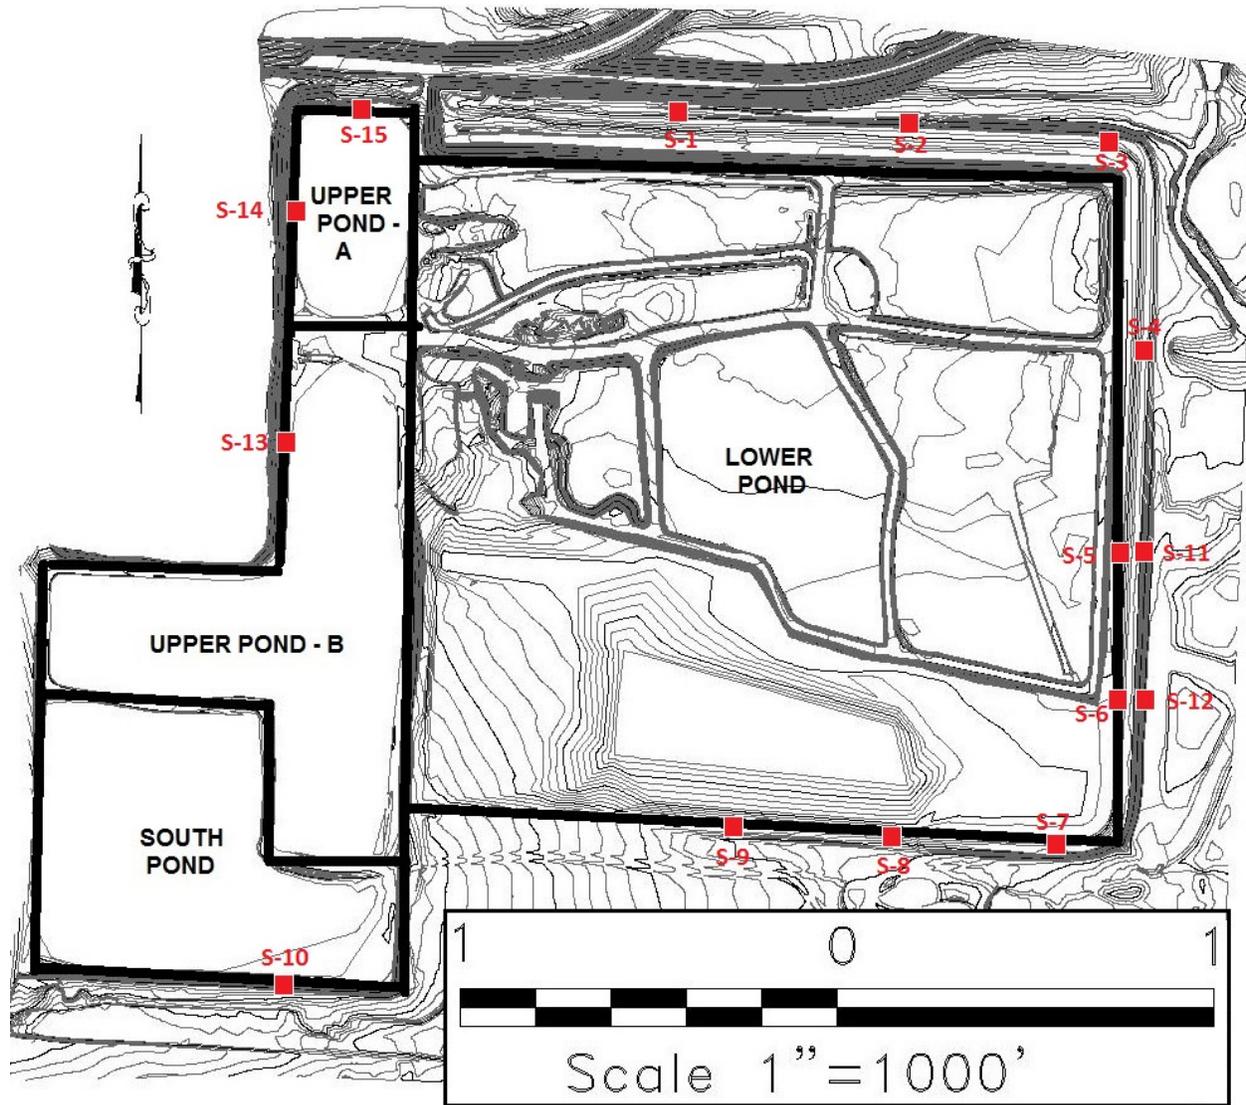
The general location of the vertical deflection monuments is shown on the Site Plan below. The vertical deflection monuments are identified as S-1 through S-15. Vertical deflection monuments S-1 through S-12 are located in close proximity to the twelve (12) settlement monuments, SM-1 through SM-12.

Liberty's Generation Performance Manager confirmed that the vertical deflection monuments have been monitored monthly over the past year, and readings have been stable over time.

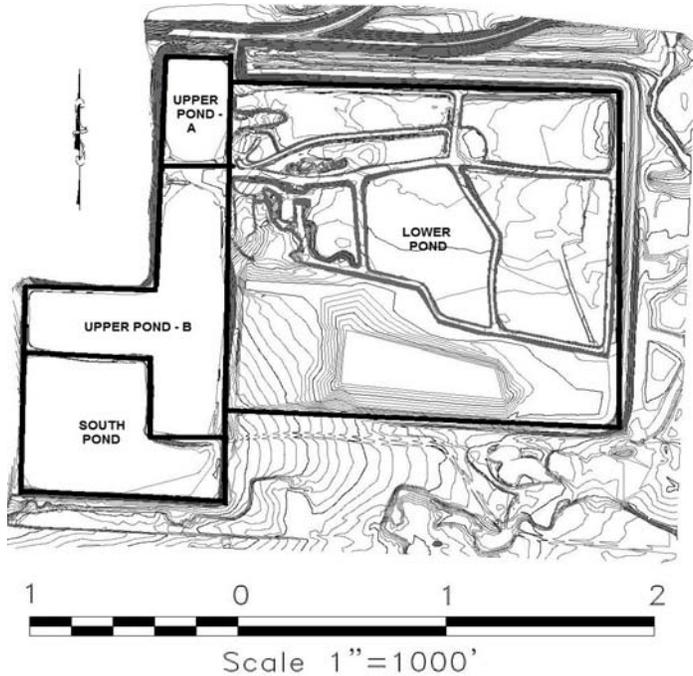
Summarize Overall Condition of Levee Embankments: The overall condition of the perimeter levee embankments is good. Evidence of sloughing or seepage was not observed during the inspection.

Summarize Areas of Concern / Recommended Action Items: Liberty should review the condition of the levee crest roadways. Significant ruts should be filled with earth fill and regraded as necessary to prevent ponded water at the levee crest. There is one rut that needs to be addressed on the west side of Upper Pond A.

Liberty should continue to monitor the levee embankments for the presence of animal burrow holes and should continue trapping when appropriate. One animal burrow hole was noted on the South side of the South Pond and was reported to Liberty.

Overall, vegetation on the levees looked good. Liberty may want to selectively overseed in the spring.
