ANNUAL INSPECTION BY A QUALIFIED PROFESSIONAL ENGINEER

ALL CCR IMPOUNDMENTS
CCR Rule Section 257.83(b)

ASBURY POWER PLANT

RE: **Annual Inspection by a Qualified Professional Engineer –**
CCR Rule Section 257.83(b)
Empire District Electric Company – Asbury Power Plant
Asbury, Missouri
PPI Project Number: 231518-2017

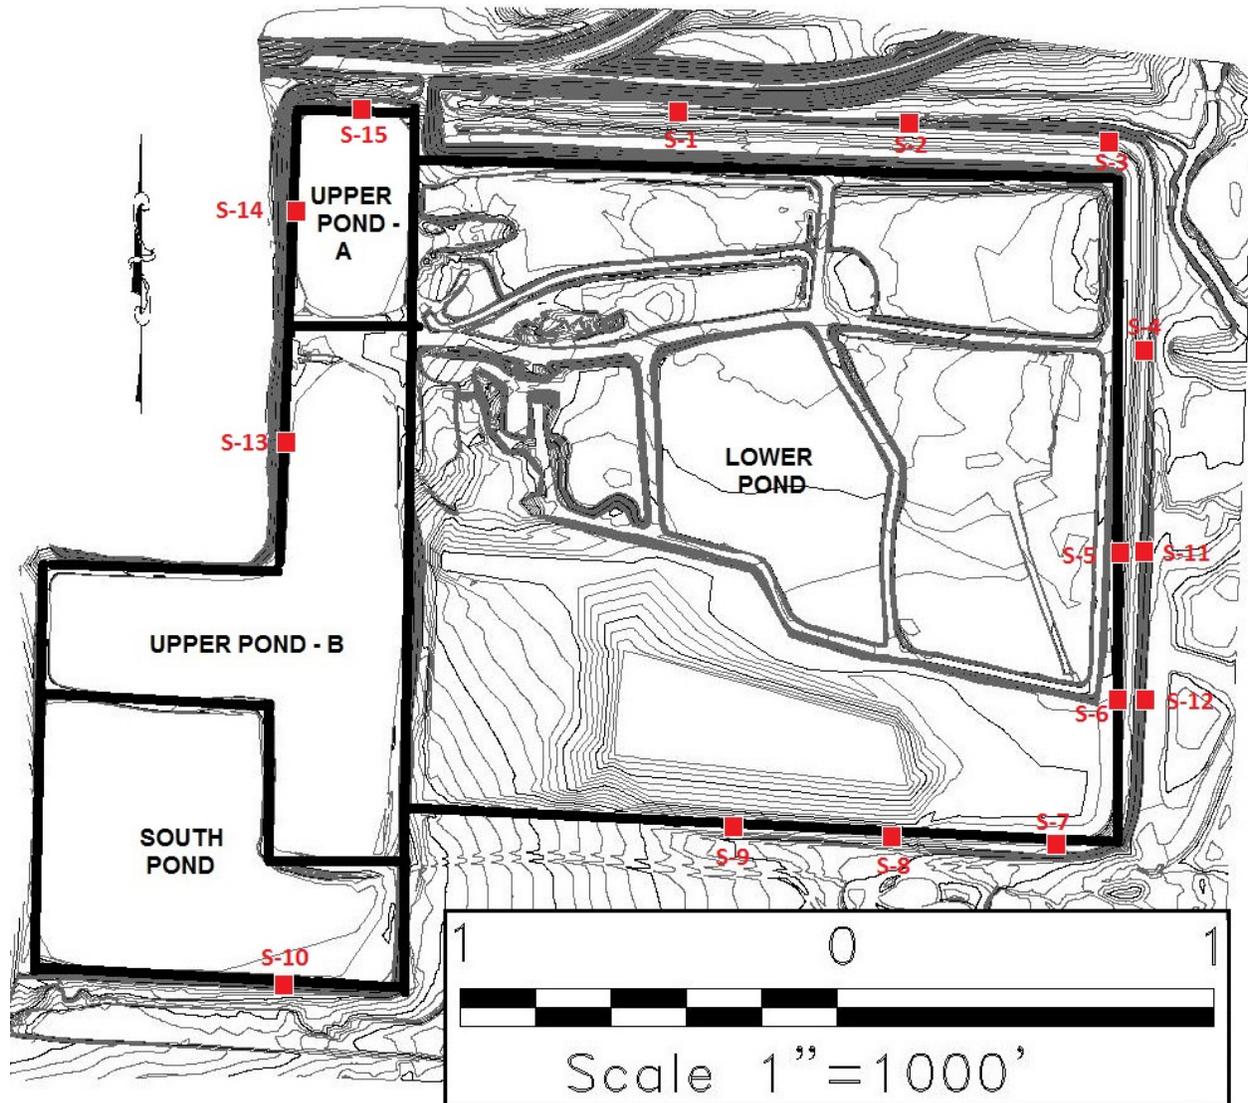
The general location of the vertical deflection monuments is shown on the Site Plan below. The vertical deflection monuments are identified as S-1 through S-15. Vertical deflection monuments S-1 through S-12 are located in close proximity to the twelve (12) settlement monuments.

The vertical deflection monuments, S-1 through S-15 have not moved more than 0.2 degrees since installation with the exception of S-7 which was disturbed during site maintenance activities.
