ANNUAL INSPECTION BY A QUALIFIED PROFESSIONAL ENGINEER

ALL CCR IMPOUNDMENTS
CCR Rule Section 257.83(b)

ASBURY POWER PLANT

January 18, 2018

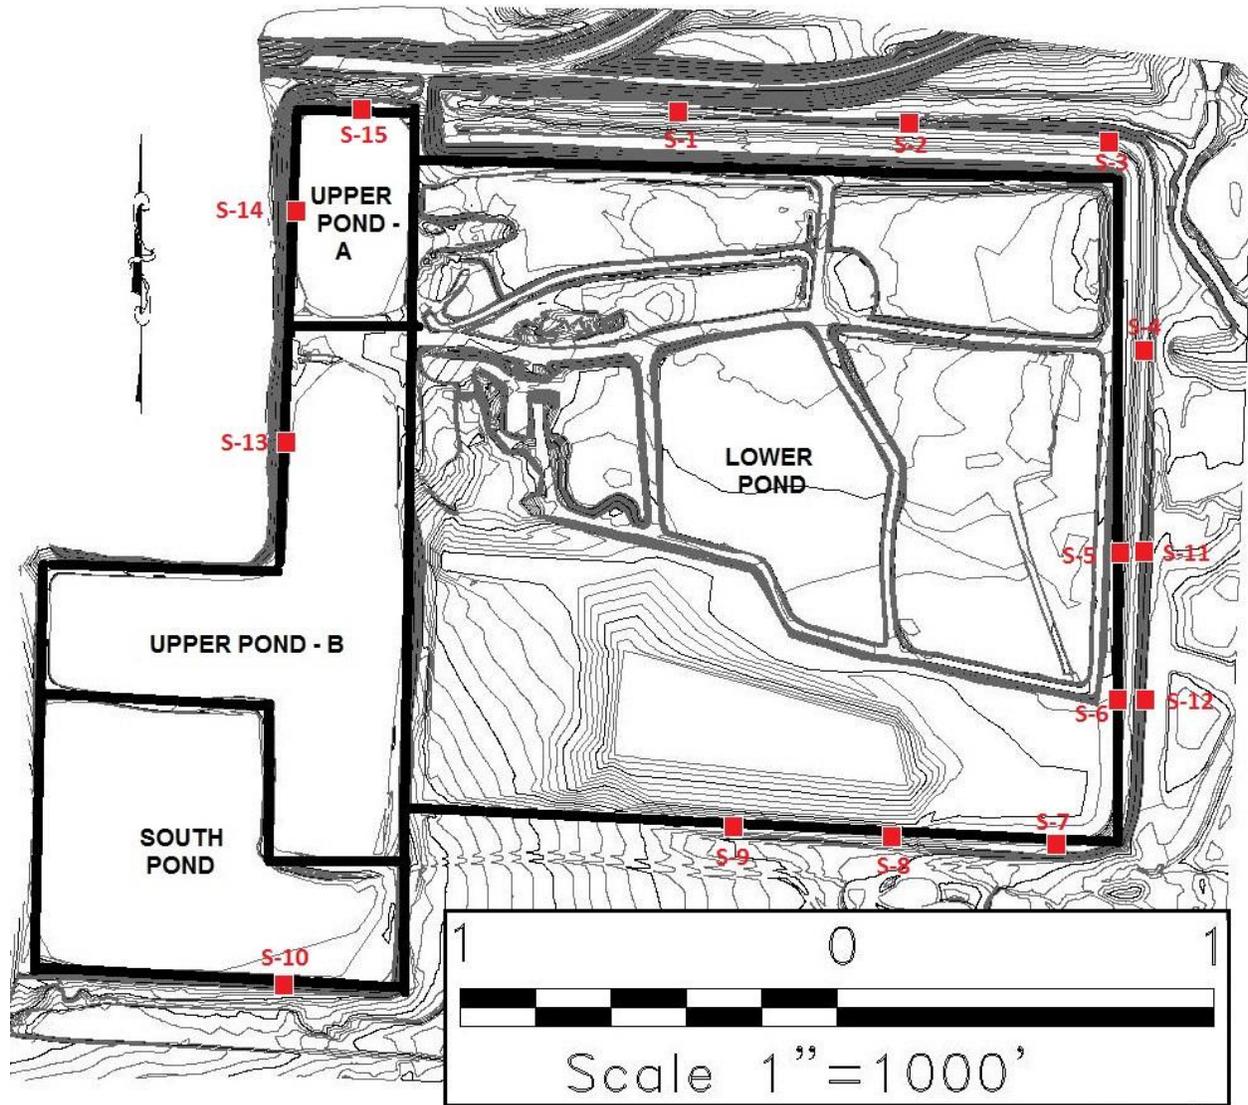
The general location of the vertical deflection monuments is shown on the Site Plan below. The vertical deflection monuments are identified as S-1 through S-15. Vertical deflection monuments S-1 through S-15 are located in close proximity to the twelve (12) settlement monuments, SM-1 through SM-12.

PPI reviewed the data set from the vertical deflection monuments with Empire’s Maintenance Manager on the date of the levee inspection. Over the past approximately 18 months, the vertical deflection monuments have been stable. S-7 was previously disturbed during site maintenance activities but has been stable since that time.
