ANNUAL INSPECTION BY A QUALIFIED PROFESSIONAL ENGINEER

ALL CCR IMPOUNDMENTS
CCR Rule Section 257.83(b)

ASBURY POWER PLANT

January 18, 2019

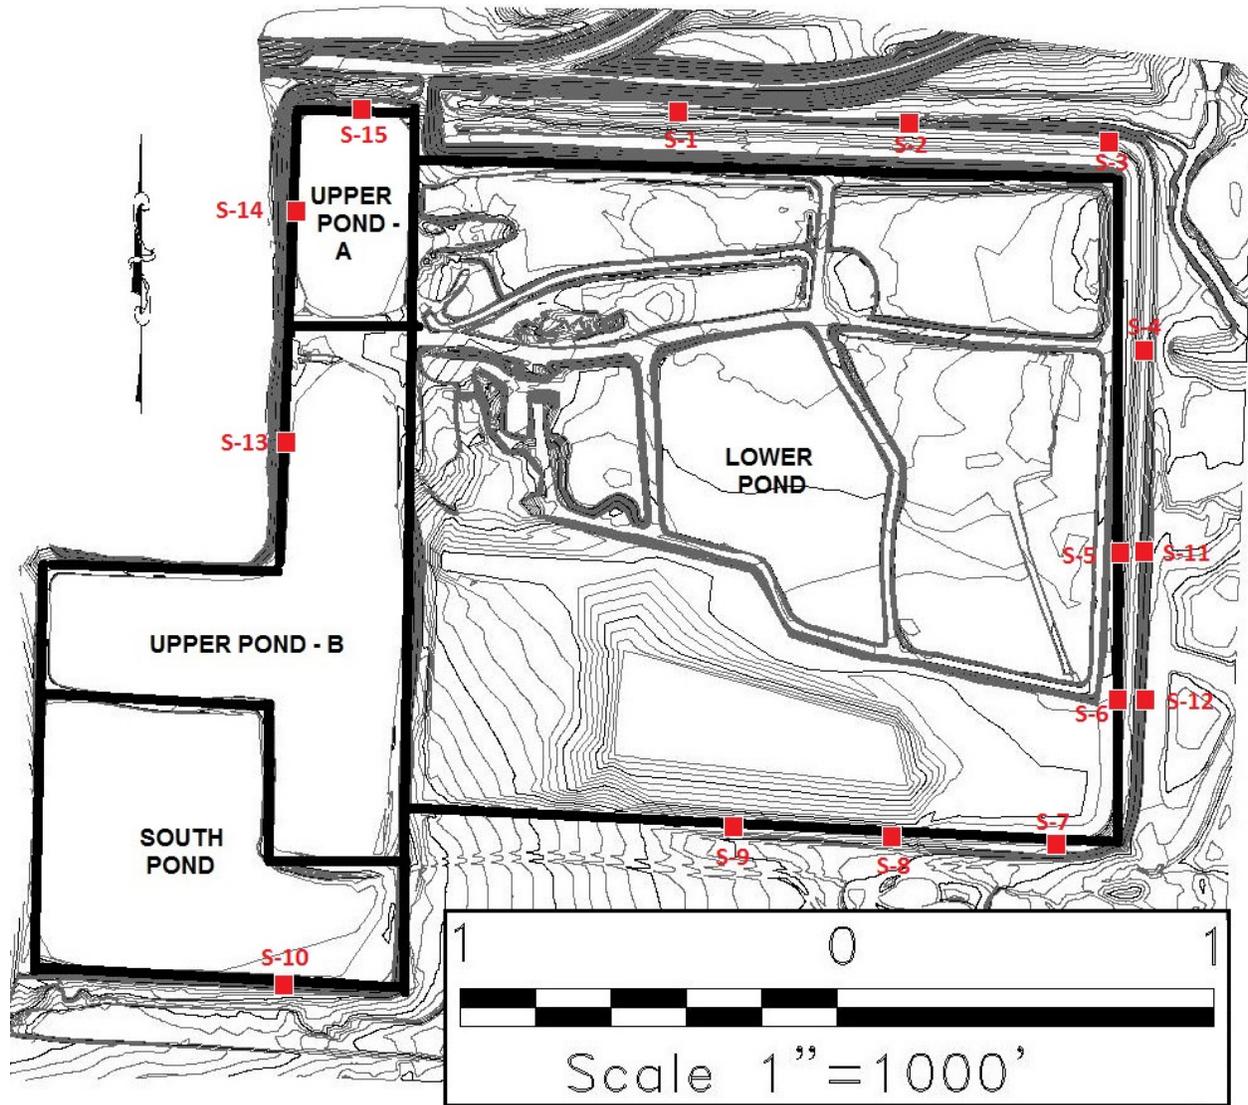
The general location of the vertical deflection monuments is shown on the Site Plan below. The vertical deflection monuments are identified as S-1 through S-15. Vertical deflection monuments S-1 through S-12 are located in close proximity to the twelve (12) settlement monuments, SM-1 through SM-12.

Liberty's Maintenance Manager confirmed that the vertical deflection monuments have been monitored monthly over the past year, and readings have been stable over time.
