# ANNUAL INSPECTION BY A QUALIFIED PROFESSIONAL ENGINEER

ALL CCR IMPOUNDMENTS  
*CCR Rule Section 257.83(b)*

## ASBURY POWER PLANT

January 17, 2021

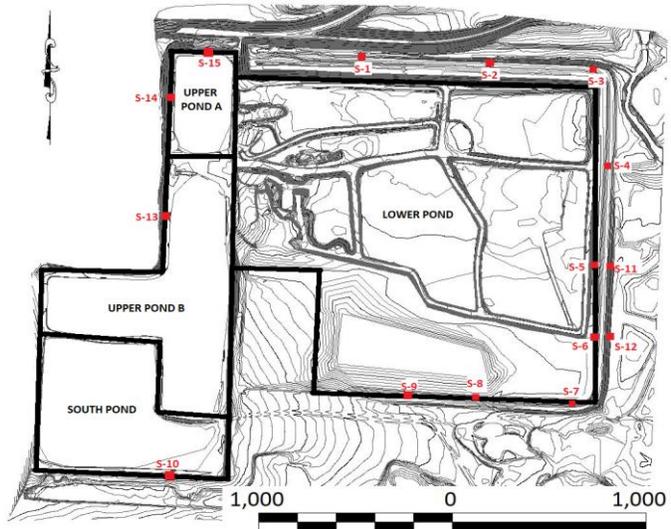
Summarize Overall Condition of Levee Embankments: The overall condition of the perimeter levee embankments is good. Evidence of sloughing at the crest of the soil levee embankment crest was not observed. Seepage was not observed. Vegetative growth on the embankments looked good overall.
