ANNUAL INSPECTION BY A QUALIFIED PROFESSIONAL ENGINEER

ALL CCR IMPOUNDMENTS
CCR Rule Section 257.83(b)

ASBURY POWER PLANT

RE: **Annual Inspection by a Qualified Professional Engineer –**
CCR Rule Section 257.83(b)
The Empire District Electric Company – Asbury Power Plant
Asbury, Missouri
PPI Project Number: 231518-2022

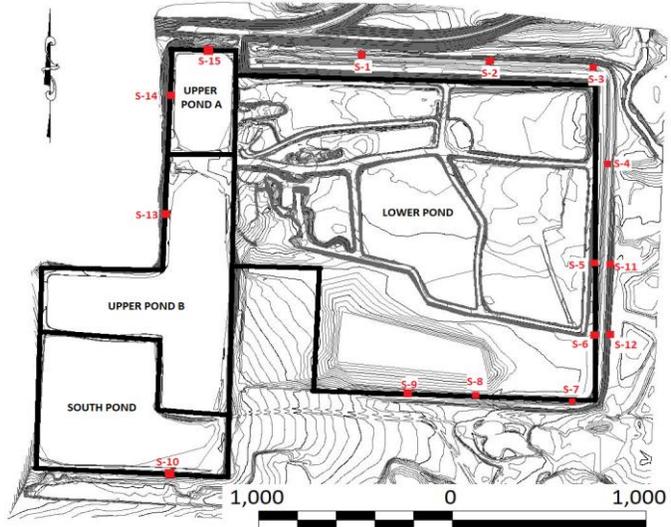
Summarize Overall Condition of Levee Embankments: The overall condition of the perimeter levee embankments is good. Evidence of sloughing at the crest of the soil levee embankment crest was not observed. Seepage was not observed. Vegetative growth on the embankments looked good overall.
